Aquatic Biodiversity Impact Assessment

Proposed Residential Development for Portion 91 / 304 Matjesfontein, Plettenberg Bay

Prepared For: EcoRoute
Author: Dr. Jackie Dabrowski
Confluent Environmental Pty (Ltd)
7 St. Johns Street,
Dormehls Drift,
George, 6529
Contact jackie@confluent.co.za
083 256 3159
SACNASP: 115166 (Aquatic Science)
Date: February 2025
Version: Version 4 (Updated SDP,
mitigation measures & stormwater
plan)

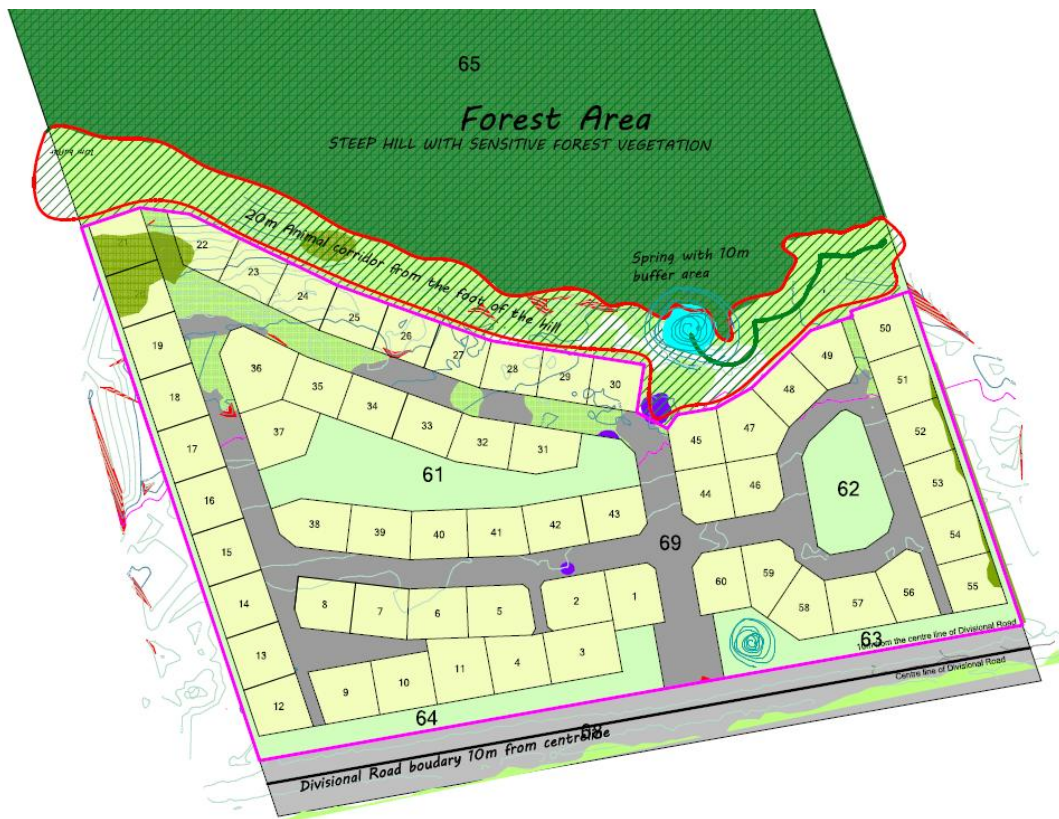
Figure 3. Preferred lower density development (January 2025). This SDP has been modified to pull Unit 50 back from the wildlife corridor which was recommended in a previous version of this report.

The abovementioned features are all plotted in relation to the preferred layout and presented in Figure 19. In most cases the layout provides a greater corridor than 20 m and the area around the pond is more extensive than the 10 m buffer. The only major 'pinch point' is the erf located on the north-east of the development indicated as **plot no. 50** in Figure 3.

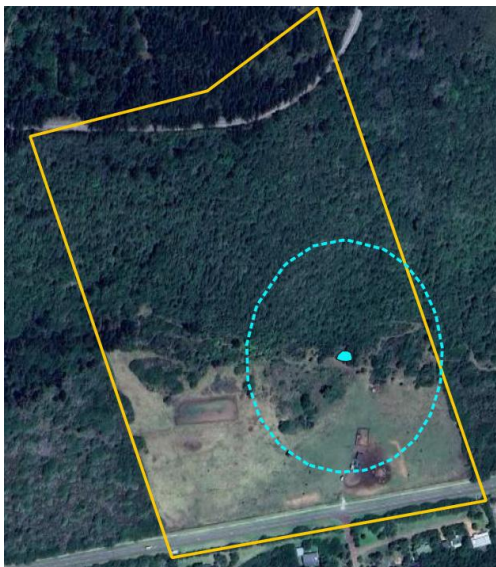
The regulated area of a spring is defined as the outer edge of the 1:100 year floodline or delineated riparian habitat, whichever is the greatest distance, measured from the middle of a river, spring, natural channel, dams and lakes. In the absence of a determined 1:100 year floodline or riparian area, the area within 100m distance from the edge of a watercourse where the edge of the watercourse is defined by the extent of open water in this case.

The image on the left shows a delineated pond excavated in front of a spring on the site and a 100m buffer indicating the development area (clear of vegetation) is within the regulated area of the watercourse.

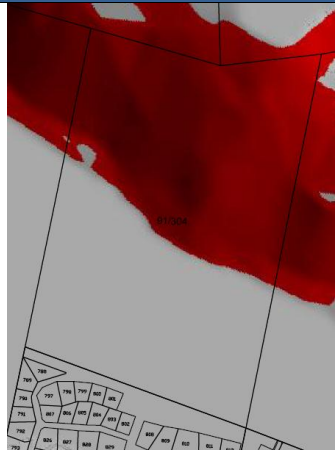
KELASP recommendations and guidelines	Graphic
<p>Development on steep slopes with a gradient > 1:4 is not supported. The area highlighted in red represents the steeply sloping land on 91/304.</p> <p><i>The development has been planned to avoid the steeply sloping areas.</i></p>

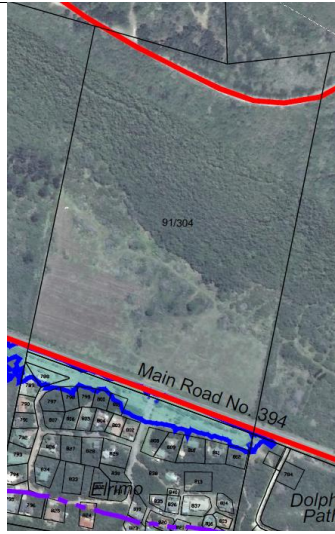
<p>Development is not supported in areas below the 1:50 and 1:100 year floodline. Lines indicated are: dark blue = 1:100 year floodline, and light blue area is an 'island' below the 1:50 year floodline. The purple line is the 100m urban coastal setback line.</p> <p><i>The proposed development area is located outside of all these features, and is therefore not flagged from a heightened flood risk perspective.</i></p>

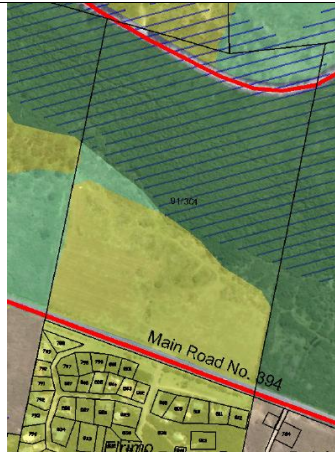
<p>Development is supported in transformed areas. The related graphic maps the southern portion of the site (proposed for development) as a 'Transformed Area' less sensitive to disturbance with opportunities for development and no natural habitat remaining. The relevant area is mapped in light green.</p>

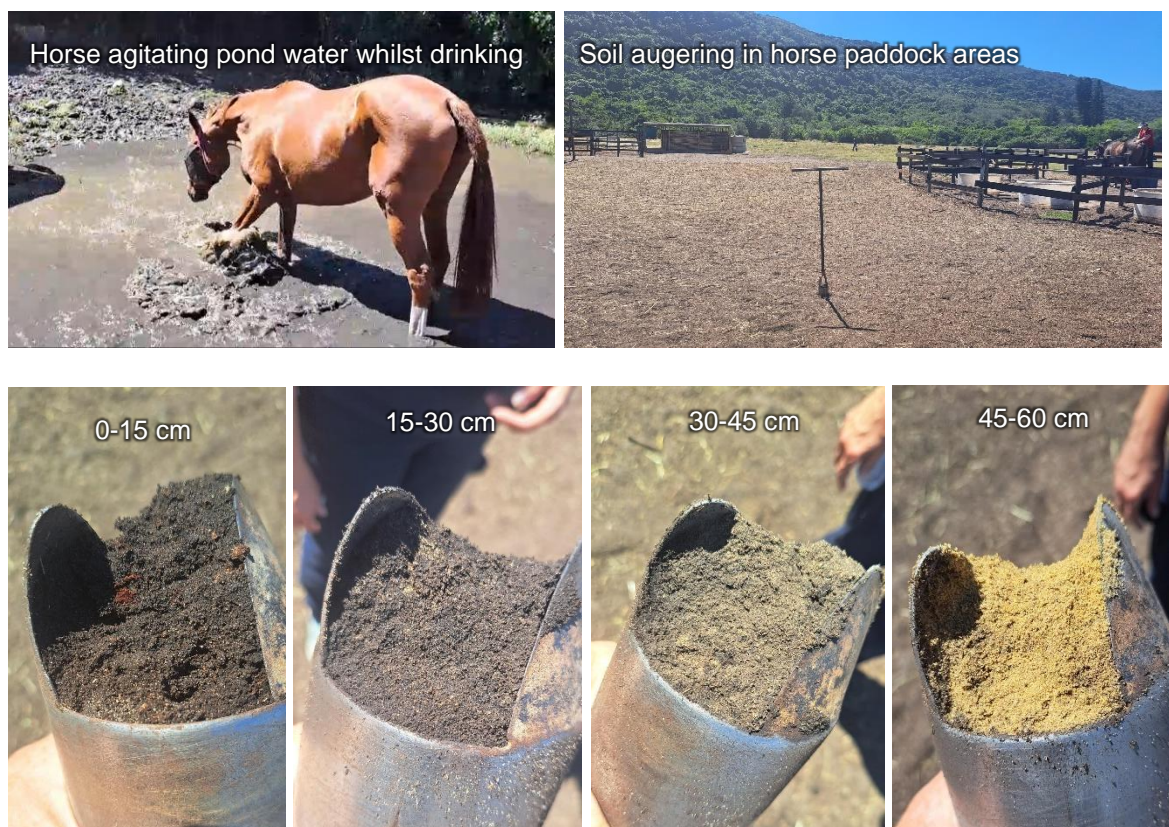
Figure 11. Photos taken during the site visit in March 2024.

During the site visit in March 2024 additional augering was undertaken in the horse paddock area as indications from Interested and Affected Parties were that the area becomes waterlogged under very heavy rainfall (Figure 11). Soil augering indicated no mottling features in the upper 50 cm of the profile, and zero wetland plants were present in the area of the horse paddocks. To the contrary the plants that have escaped grazing in this area are indicative of terrestrial habitats and do not reflect waterlogging associated with wetland or estuarine conditions. Compaction of the soil by horses combined with addition of layers such as bark chips could reduce permeability of the soil surface exacerbating standing water during periods of very high rainfall.

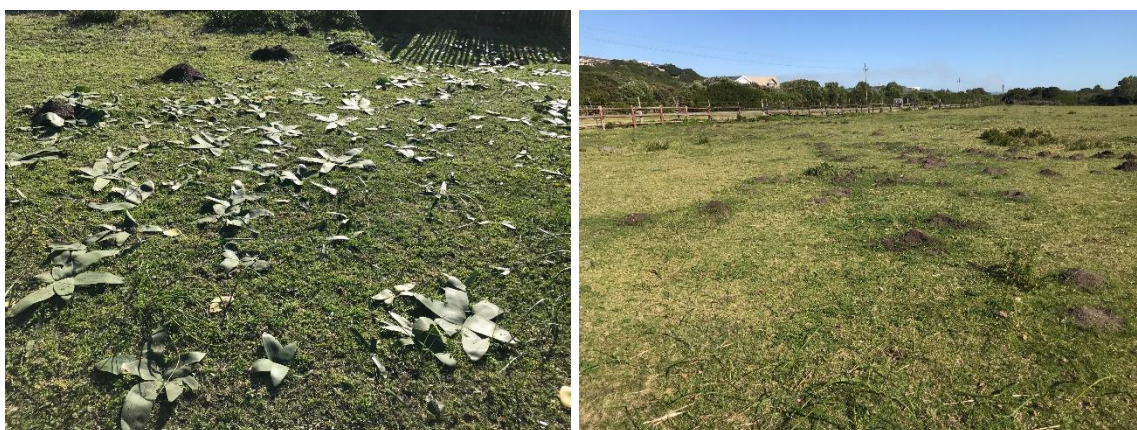
Figure 14. Typical vegetation in the grazed open area.

Only remnant patches of indigenous vegetation were present on 91/304 and these contained a couple of large specimens of Milkwood trees (*Sideroxylon inermeis*) intermingled with *Searsia* sp. Shrubs which make up thicket areas. In the grazed open area which corresponds with the mapped EFZ, the dominant plant species are numerous candelabra flowers (*Brusvigia orientalis*), *Stenotaphrum secundatum* (Buffalo Grass), *Mesembryanthemum* spp. (ice plants), *Romulea* spp. (Froetangs), *Carprobrotus* sp., *Searsia crenata* (Dunekraaibessie), *Salvia aurea* (brown sage), and *Massonia longipes* (coastal hedgehog lily).

While these species are typically associated with coastal, sandy habitats, they are not strictly associated with estuarine systems including the upper extent of the tidal zone. Furthermore, no estuarine species from any of the tidal habitats including saltmarsh or supra-tidal vegetation were identified at the site. These species would typically include rushes and sedges such as *Juncus kraussii*, *Cyperus laevigatus*, *Ficinia nodosa* or *Phragmites australis*.

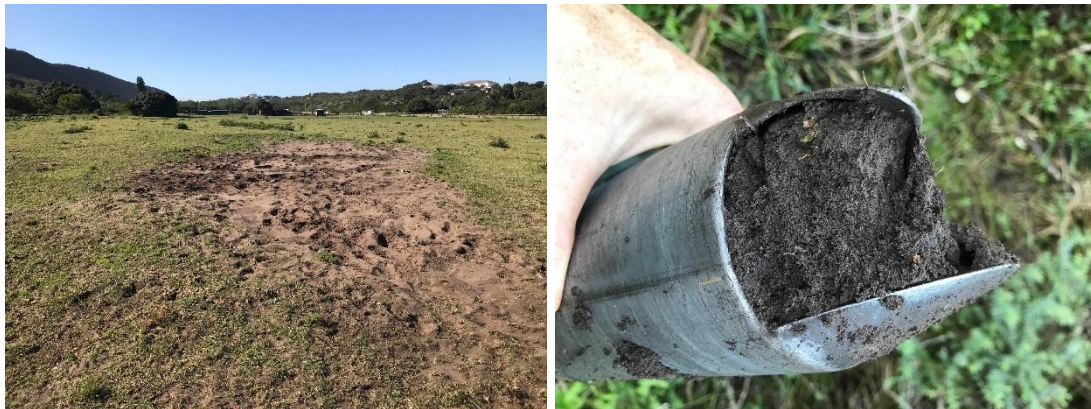
Figure 15. Sandy soils present at the site with no indicators of permanent or seasonal saturation (28 June 2022).

Soil augering at the site indicated deep, sandy, well drained soil with no textural change at 50 cm which could promote the development of wetland habitat (Figure 15). This is consistent with the mapped soil type in the area which is described as soils with limited pedological development (young soils with minimal organic matter), and a low clay content (< 15%).
