REHABILITATION PLAN

FARM RE/139 GROOTBRAK

Mossel Bay Municipal District

Cape EAPrac, 2022. Rehabilitation Plan – Farm RE/139 GROOTBRAK

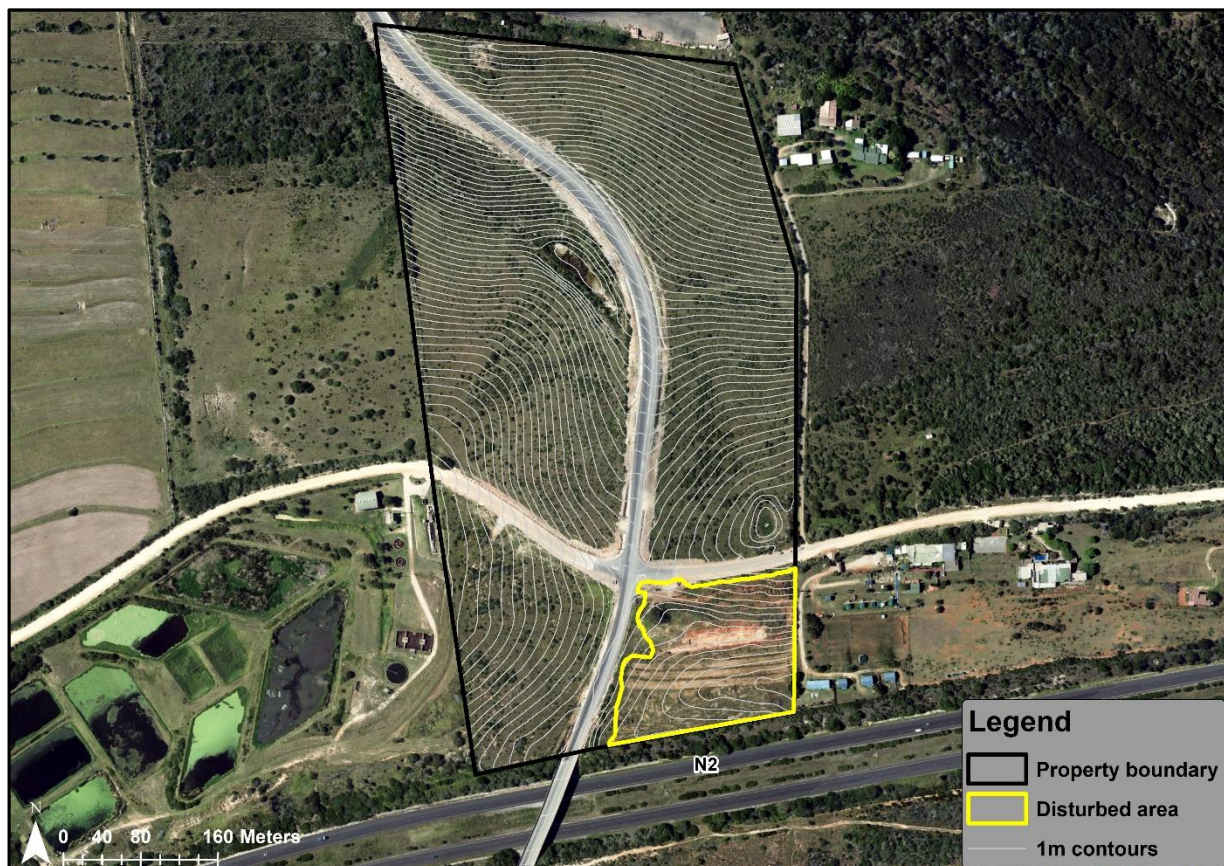
Figure 1: Property location

The overall size of the property is approximately **27ha** and is located roughly **1km West** of the village of Great Brak River and **22km East** of Mossel Bay. The N2 road borders the southern boundary. Surrounding land use to the north, west and south include agriculture, small holdings and municipal water treatment facility on the western boundary. The property is **vacant** and rises approximately **131m above Mean Sea Level** at its highest point in the North (Figure 1).

The Applicant cleared approximately **25 853m² (2.58ha)** of vegetation and excavated soil to create flat bench areas to start producing bricks. The site has a moderate slope and an elevation up to 94m above MSL (Figures 1 & 2). The portion of the property that has been impacted by the disturbance was previously used for agricultural purposes for more than 18 years (Figure 5). The site was inspected on 22 September 2022 by the EAP. It is evident that natural vegetation regrowth has started to recover since initial clearing in 2021, with no major signs of erosion.

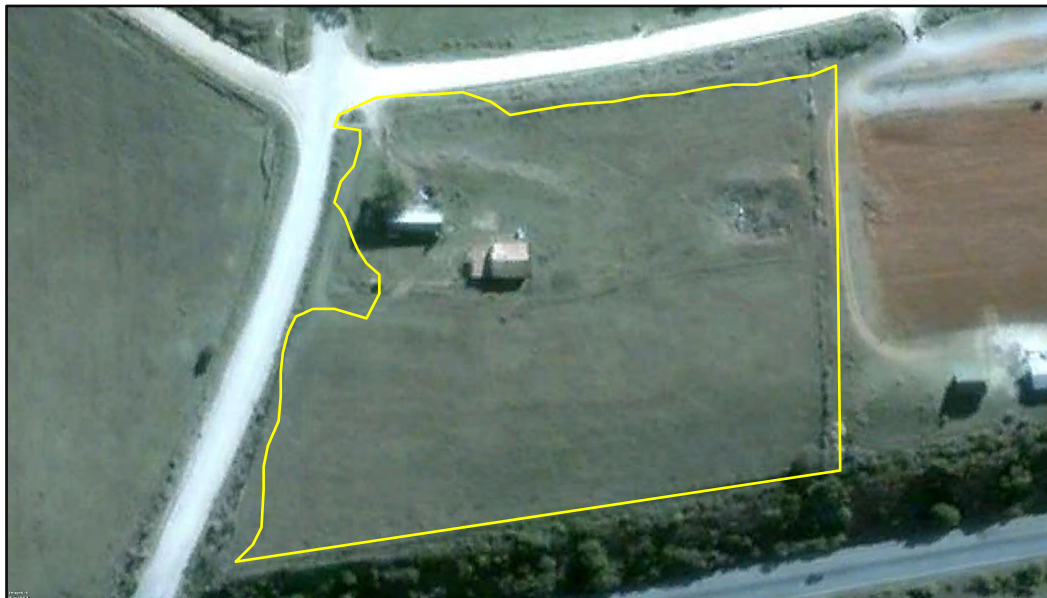
Figure 3: Google Earth image (2004) of the disturbed area

The portion of the property that has been impacted by the disturbance (vegetation removal and excavation) and has been used for agricultural purposes (mostly grazing) for more than 18 years preceding the recent clearing (Figure 3).

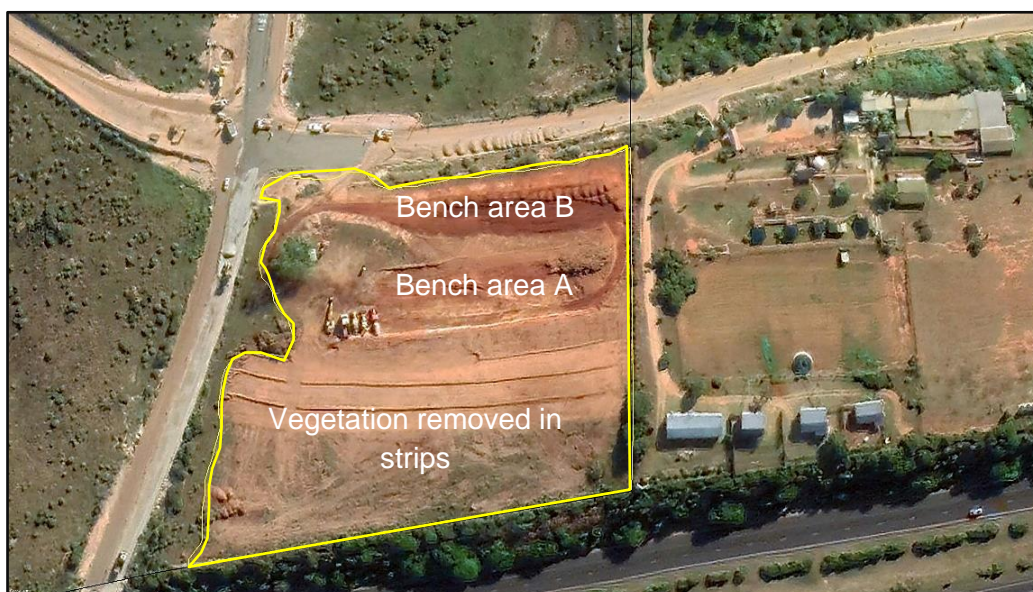
Figure 4: Google Earth image (2020) showing the disturbed area

The Applicant cleared vegetation with heavy machinery covering an area of approximately 25 853m² and undertook earthworks to create two flat bench areas to produce cement bricks. The vegetation and excavated soil were partially removed from the site with some stockpile material at the bottom of the site (Figure 4).

The activities to create the disturbance on the site included the following (Figure 4):

- Earthworks to create bench A (4 365m²)
- Earthworks to create bench B (5 168m²)
- Removal of vegetation in strips (5 168m²)

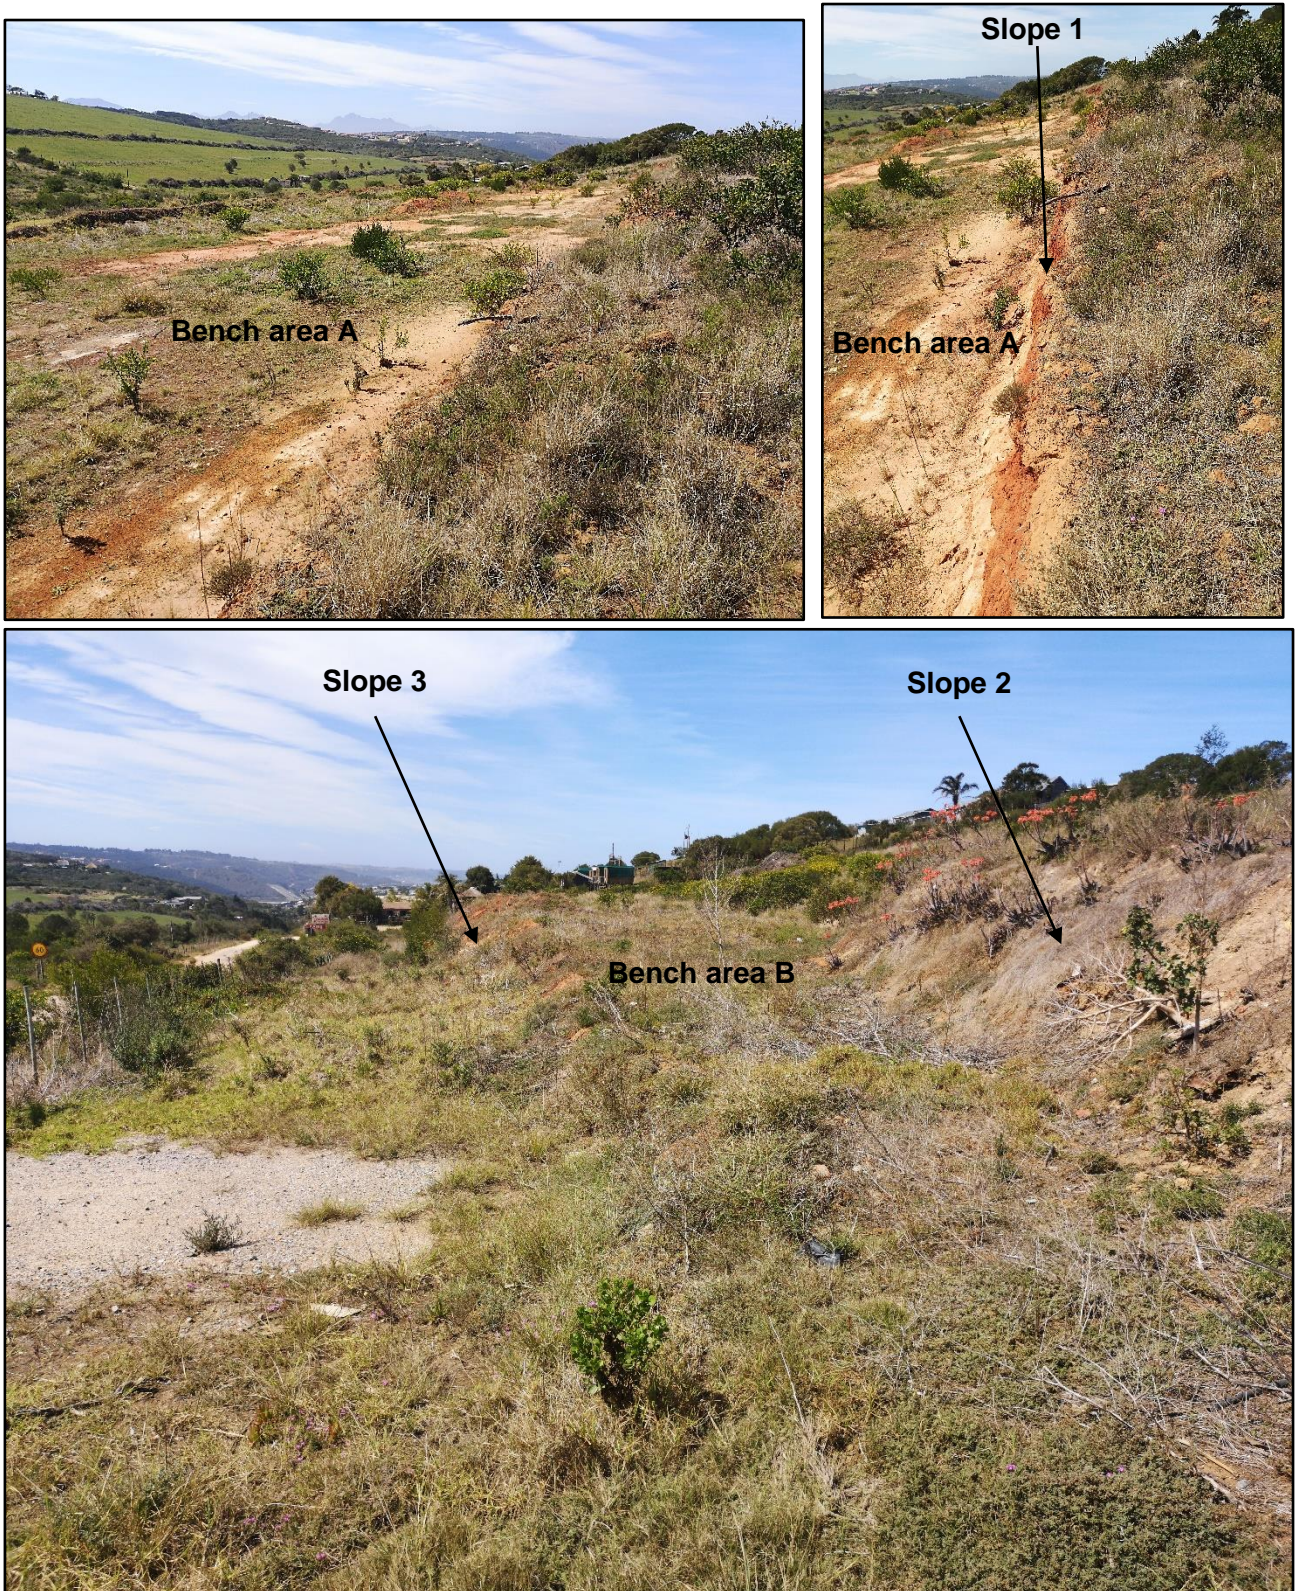
Figure 5: Excavated areas

The site was inspected on 22 September 2022 and several photographs were taken of the disturbed area (Figure 5)

Despite the level of disturbance and earthworks, at the time of the site visit, it was evident that vegetation has established very well on the disturbed areas except on the steep slope (cut) at bench A (Figures 5 & 6).

- Bench areas A & B are **not to be backfilled** due to the **good recovery of the vegetation** with groundcover already established (backfilling will result in the loss of natural vegetation all over again);
- The top area where only vegetation was removed in strips requires no activity rehabilitation due to the natural recovery of vegetation where **groundcover has been established**.
- Slope one (1) is 90° and must be **re-shaped** to the same angle as Slope two (2) and three (3) to prevent erosion and allow vegetation to recover.
- Slopes two and three require **no further shaping** because they are not as steep as Slope one and vegetation has already established on them which prevents unwanted erosion from happening (Figures 5-7).
